# TROUBLESHOOTING GUIDE FOR USB ALL SKY CAMERA

Created : 05/12/2020  
Updated on : 02/10/2025  
Written by : C.CAVADORE

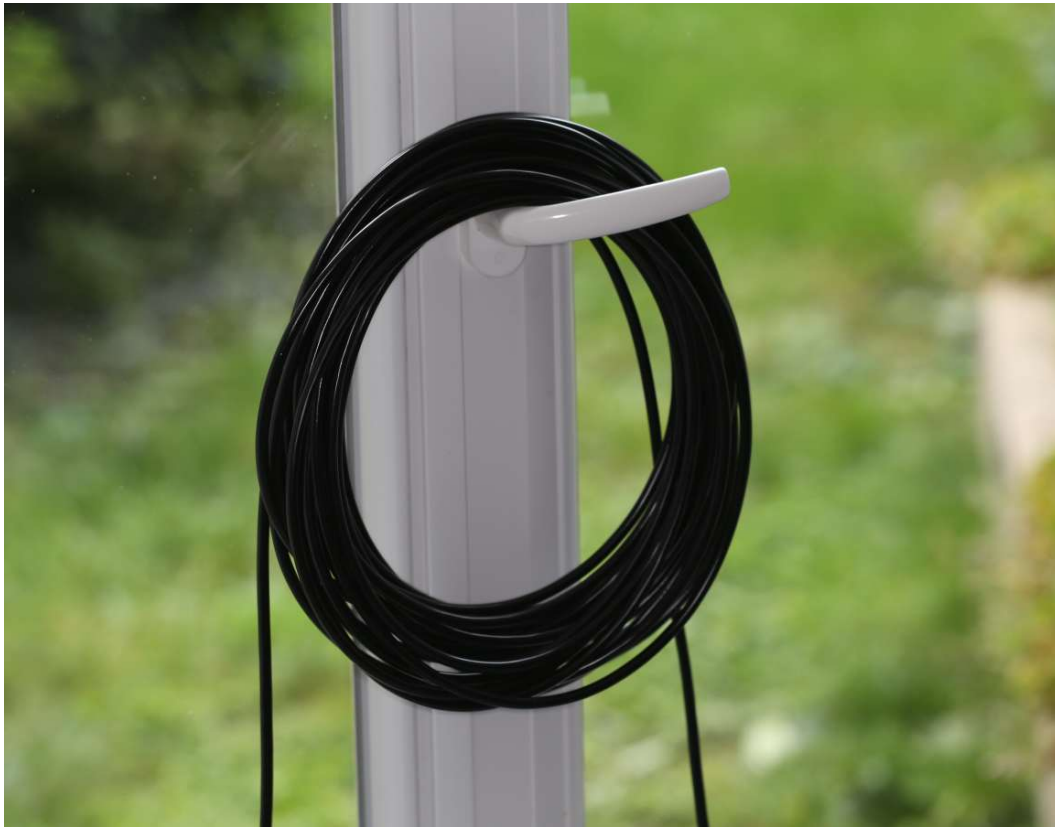
Do not do this !

It is strictly unadvised to coil/loop the USB or the power-RS232 cable because it is too long, like in the picture below. This can be convenient to reduce the footprint of the cable, but this can lead to disasters. When a lightning strike occurs, even, say, at up to 100m/200m from the camera, a huge magnetic field change is produced in a very short amount of time. The cable, put in coils, can turn into a voltage this magnetic field change that will be directly multiplied by the number of cable loops. This is called induction (please read this

At the end of the cables, a voltage higher than 30 000 volts can be created and destroy all camera electronics or damage electronic boards, in a way that image data transfer from camera to the PC can be halted in a random fashion. It can be difficult to assess the root cause. Our cameras are tested in factory outdoors during several days and can output several thousands of images without a single glitch (or missing image).

It is sometime a good advice to use services from an electrical company that can help to reduce the risk of lightning strikes damages by proper earthing/grounding schemes and surge protection. Sometime, fiber link between the camera and the PC can be used to remove of induction damage risks.

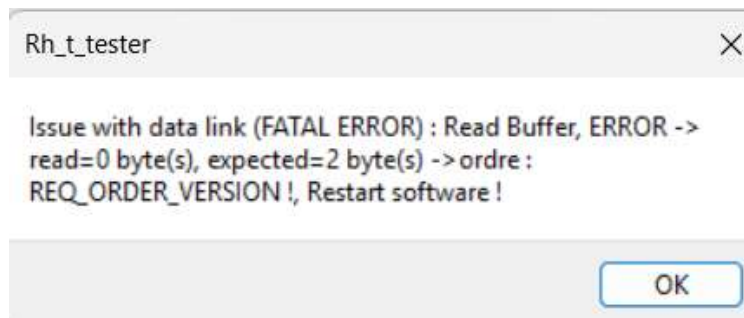
It means that

- COM port number is invalid. Try another one available.
- Camera power cable is either disconnected, damaged or 24V is not present (because the power unit is damaged).
- The internal camera weather board is damaged.

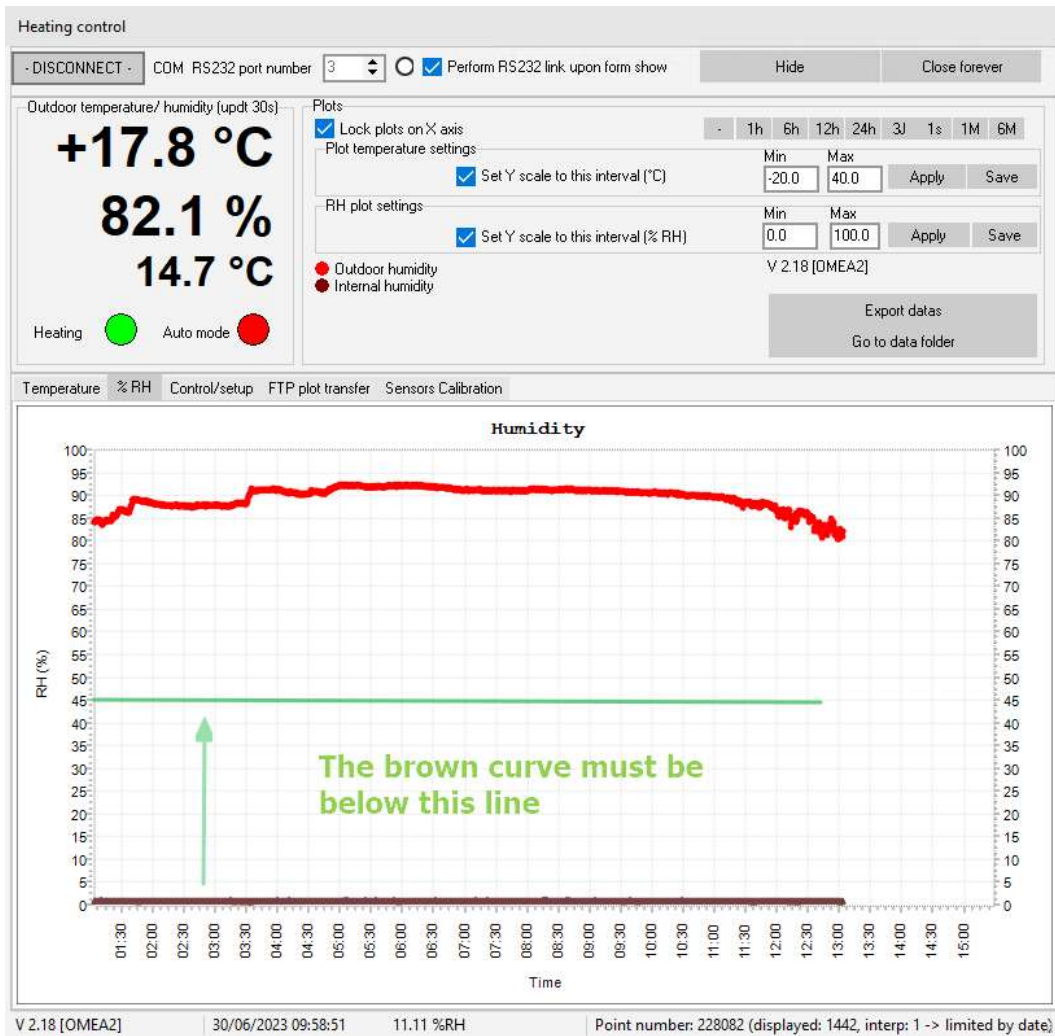
Check that the inner camera humidity is still less than 45% (OMEA and EUDA camera only). If above a leak can occur, water can pour into the bottom connectors and jeopardize USB link.

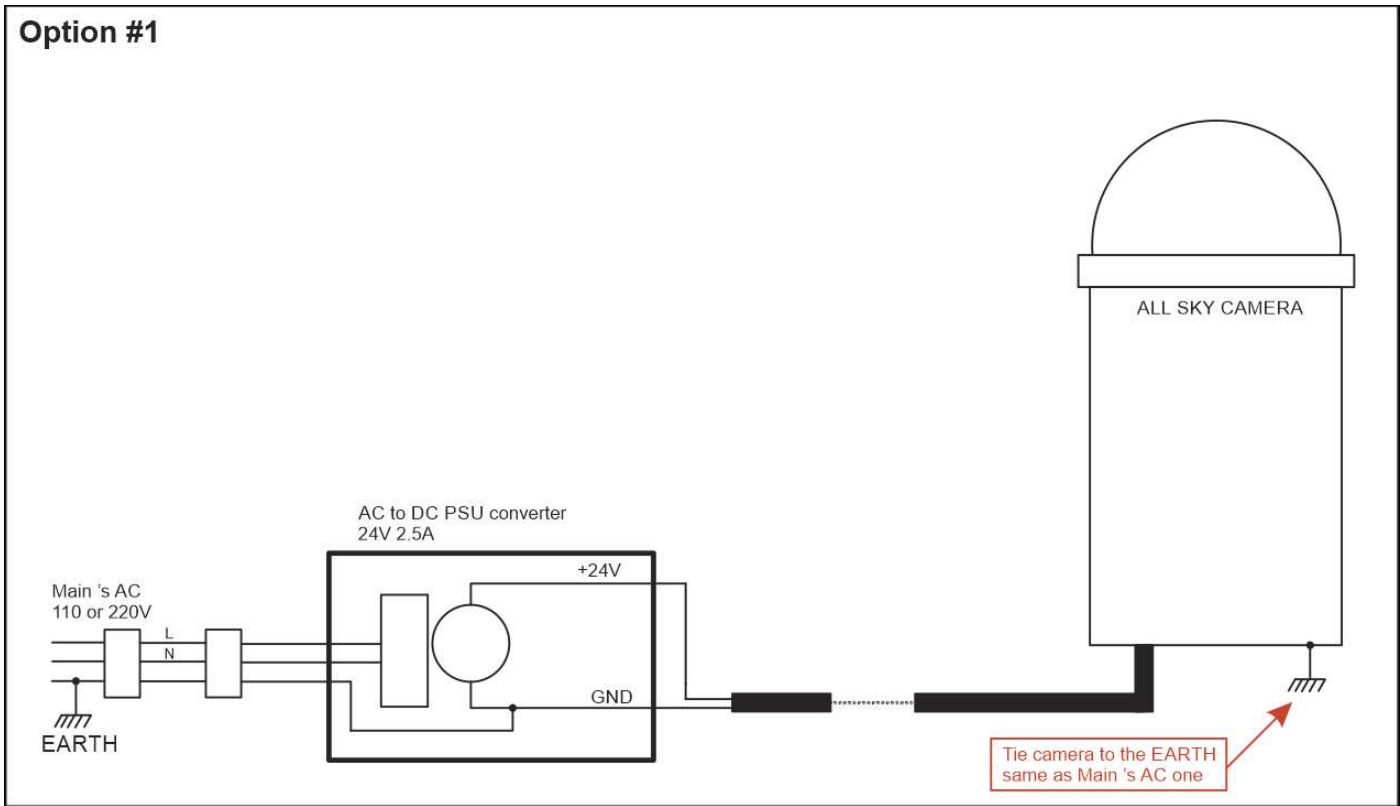
### Option #1

This issue may occur when camera dome heating turns on. In that case there is a grounding issue with the camera, the PC and the mains' AC power supply. To fix the issue there are two options: the camera earth connected (option #1) or the power supply floating option (option #2). Please proceed as below (select the best scheme for you) and this issue will be resolved. One has to keep in mind that there is a link from the camera to the PC via USB cable that has shield connected to its GND. Ground loop can occur, and finding the best grounding scheme can depend on the place, and the way your installations is earthed.

Note: for all camera sold after 01/01/2023, 24V power supply has no earth pin, in order to avoid this issue. A C8 power supply unit input is used with no earth.

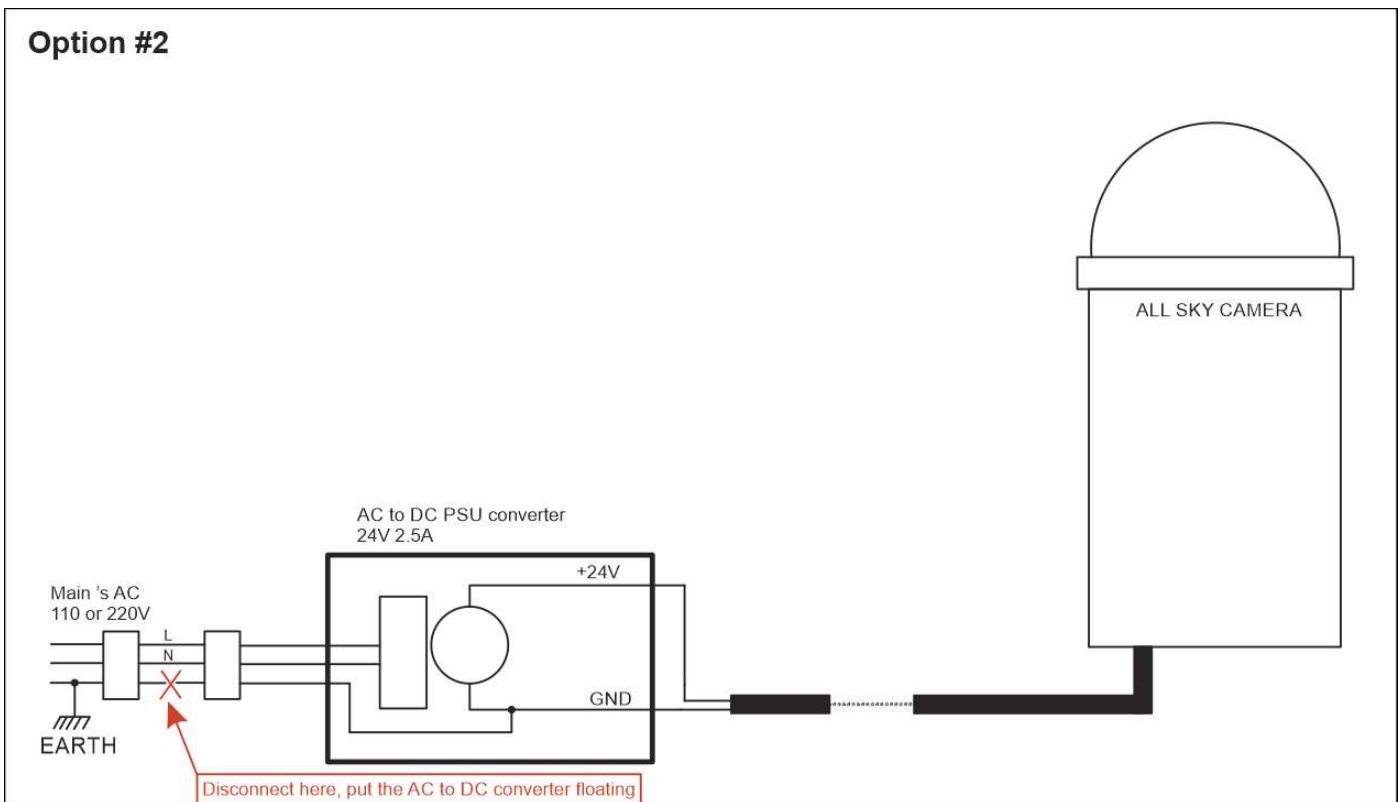
### Option #2

If camera is loss during power heating ignition, Option #2 simply solves the issue.

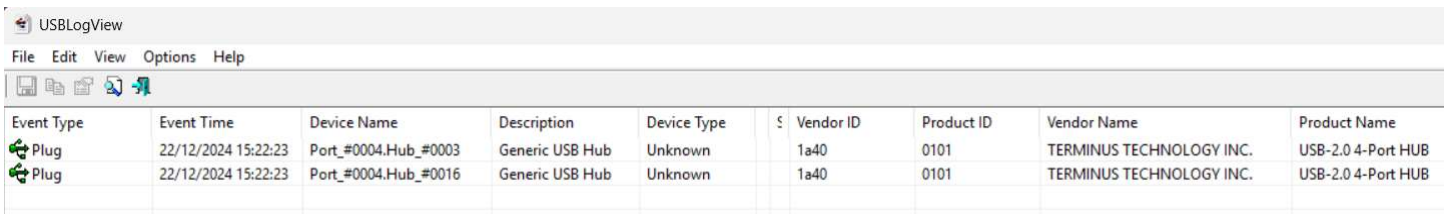
To check that the USB cable is working properly, disconnect the USB cable at PC level, start **USBLOGview** software, and connect the USB cable. At least, two new green line must appear as below :

If only one, or no green line appear, it means that one USB cable repeater is dead. So, the cable must be replaced.
