Test of a 600 mm mirror F3 at radius curvature center point

Date : 02/04/2018
Written by : C.CAVADORE

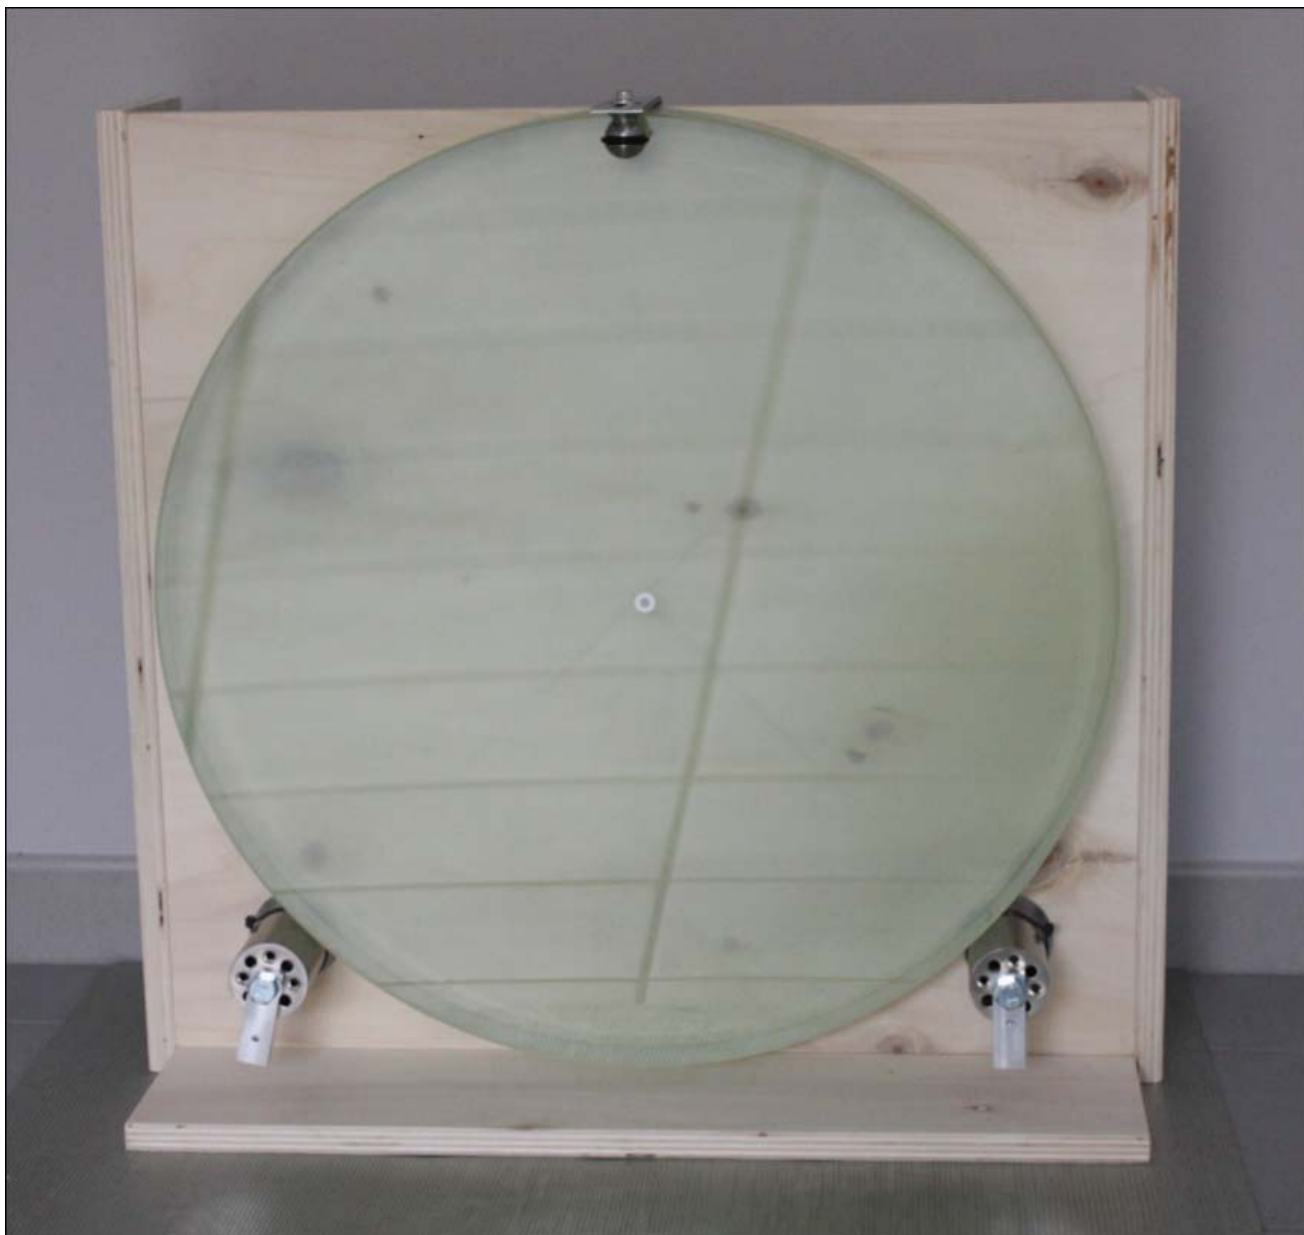
Figure 1.

The mirror to be tested is a 600 mm F3 parabolic mirror ($k=-1$). It was figured in 2007 by a company that is not to be disclosed in this report. The thickness is 57 mm, and is made of SUPRAX glass. It not coated.

The company that did figure this mirror, checked it with a knife edge test (caustic test), and claimed to be a $\lambda/19$ PTV error mirror.

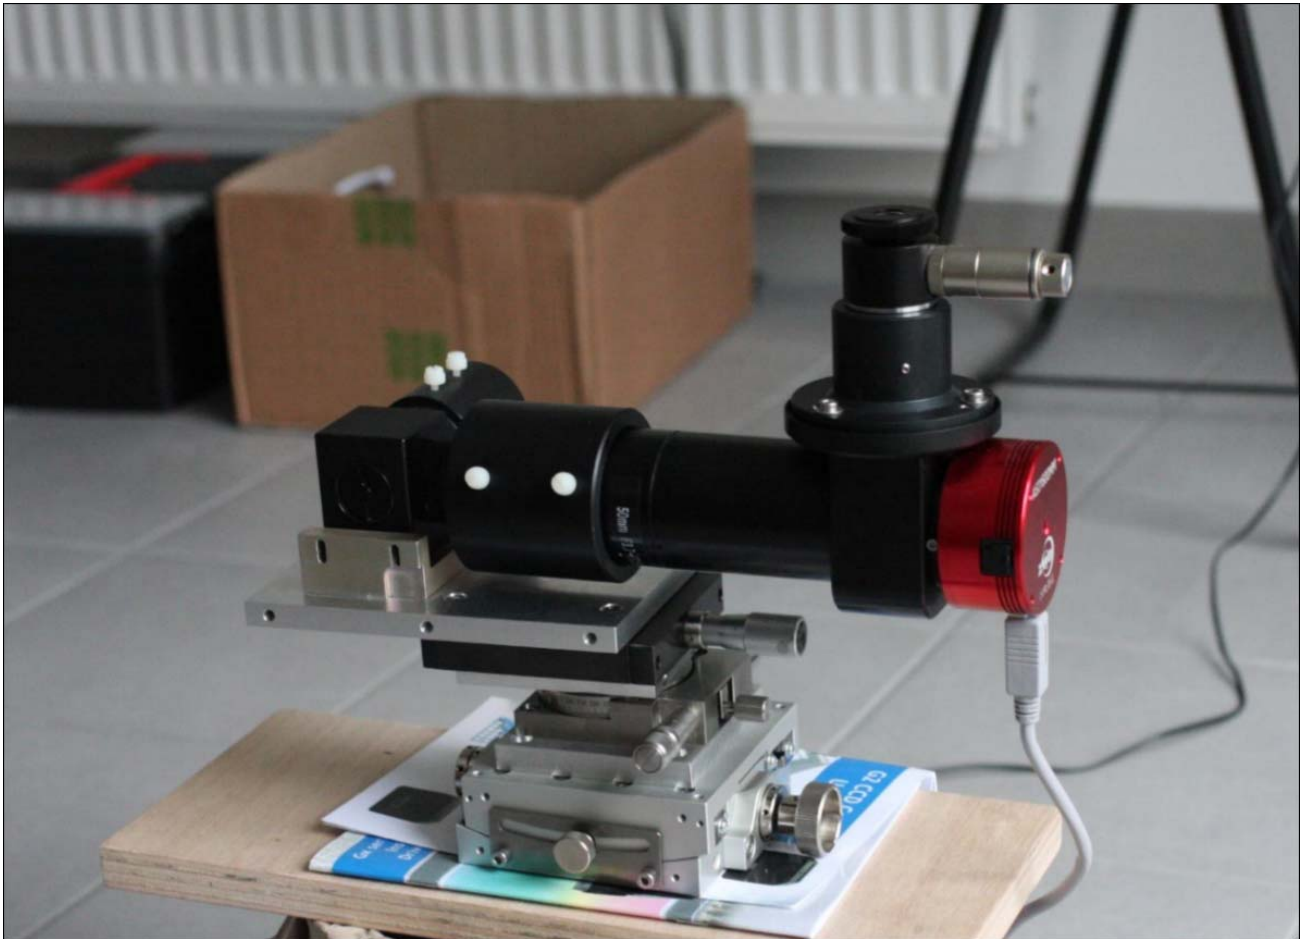
Figure 2.

The shack hartmann used is an ALCOR-SYSTEM 100x100 device, that has been put at 3.6 m from the mirror, with a 10μ led lit pinhole. A 50 mm collimator focal length has been installed. This is a center of curvature test, with an enormous spherical aberration (12.55 waves @550 nm that is 6902 nm Z8 zernike).

Many optical stages are used under the shack hartmann, because the mirror has no degree of freedom motion. A Z stage axis was missing for this test.

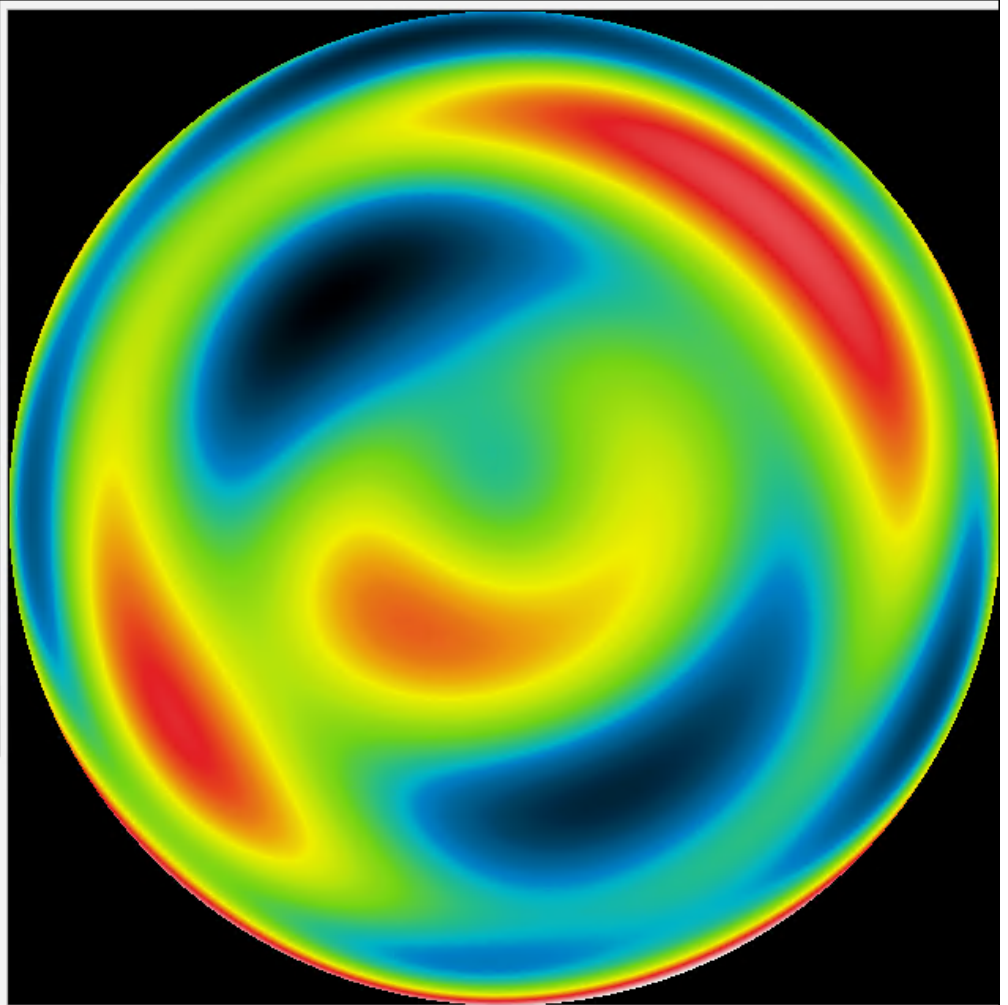
Figure 4.

The global RMS error, including astigmatism is 140 nm ($\lambda/4$ rms). This is far from $\lambda/18$ PTV measured with knife test.

Spherical aberration has been canceled out, and computed to be 6902 nm theoretically, it has been measured at 6951 nm by the Shack Hartmann, so the difference is only 50 nm that is quite good. Parabolic figuring was achieved properly and spherical aberration error is negligible for this mirror.

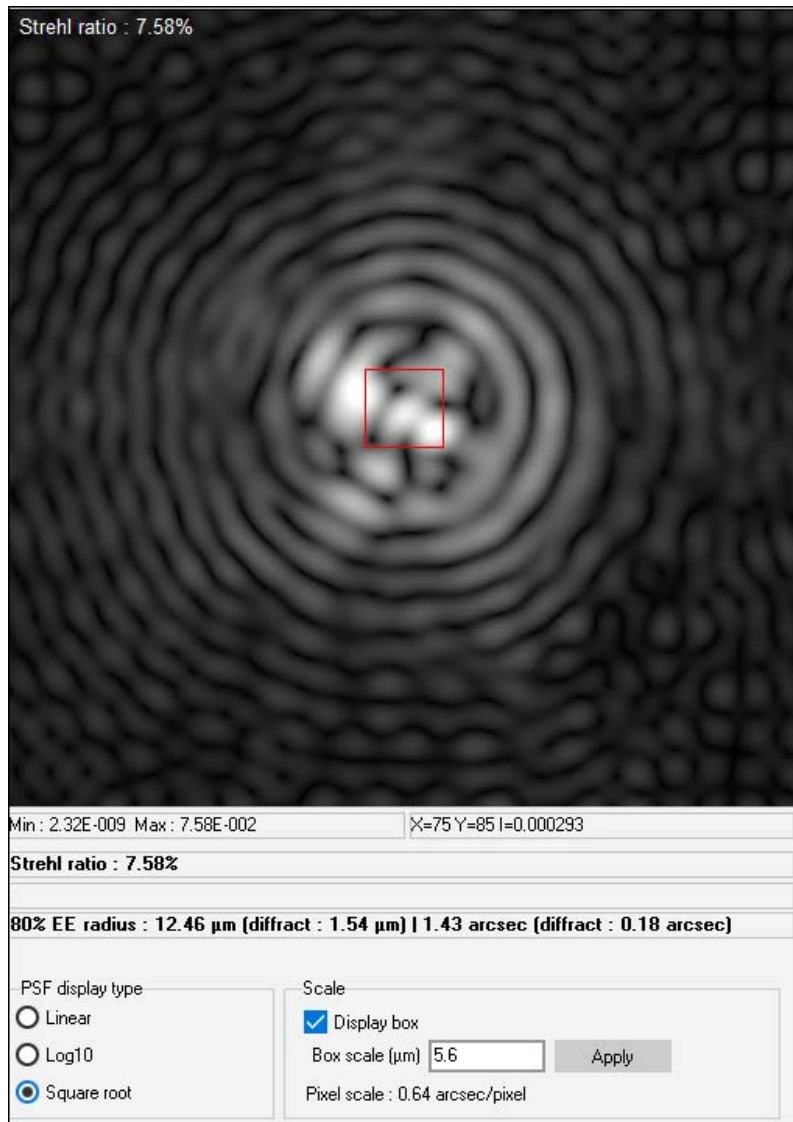
Figure 5.

PSF reconstruction shows that Strehl ratio is only 8 % that is not an outstanding performance.

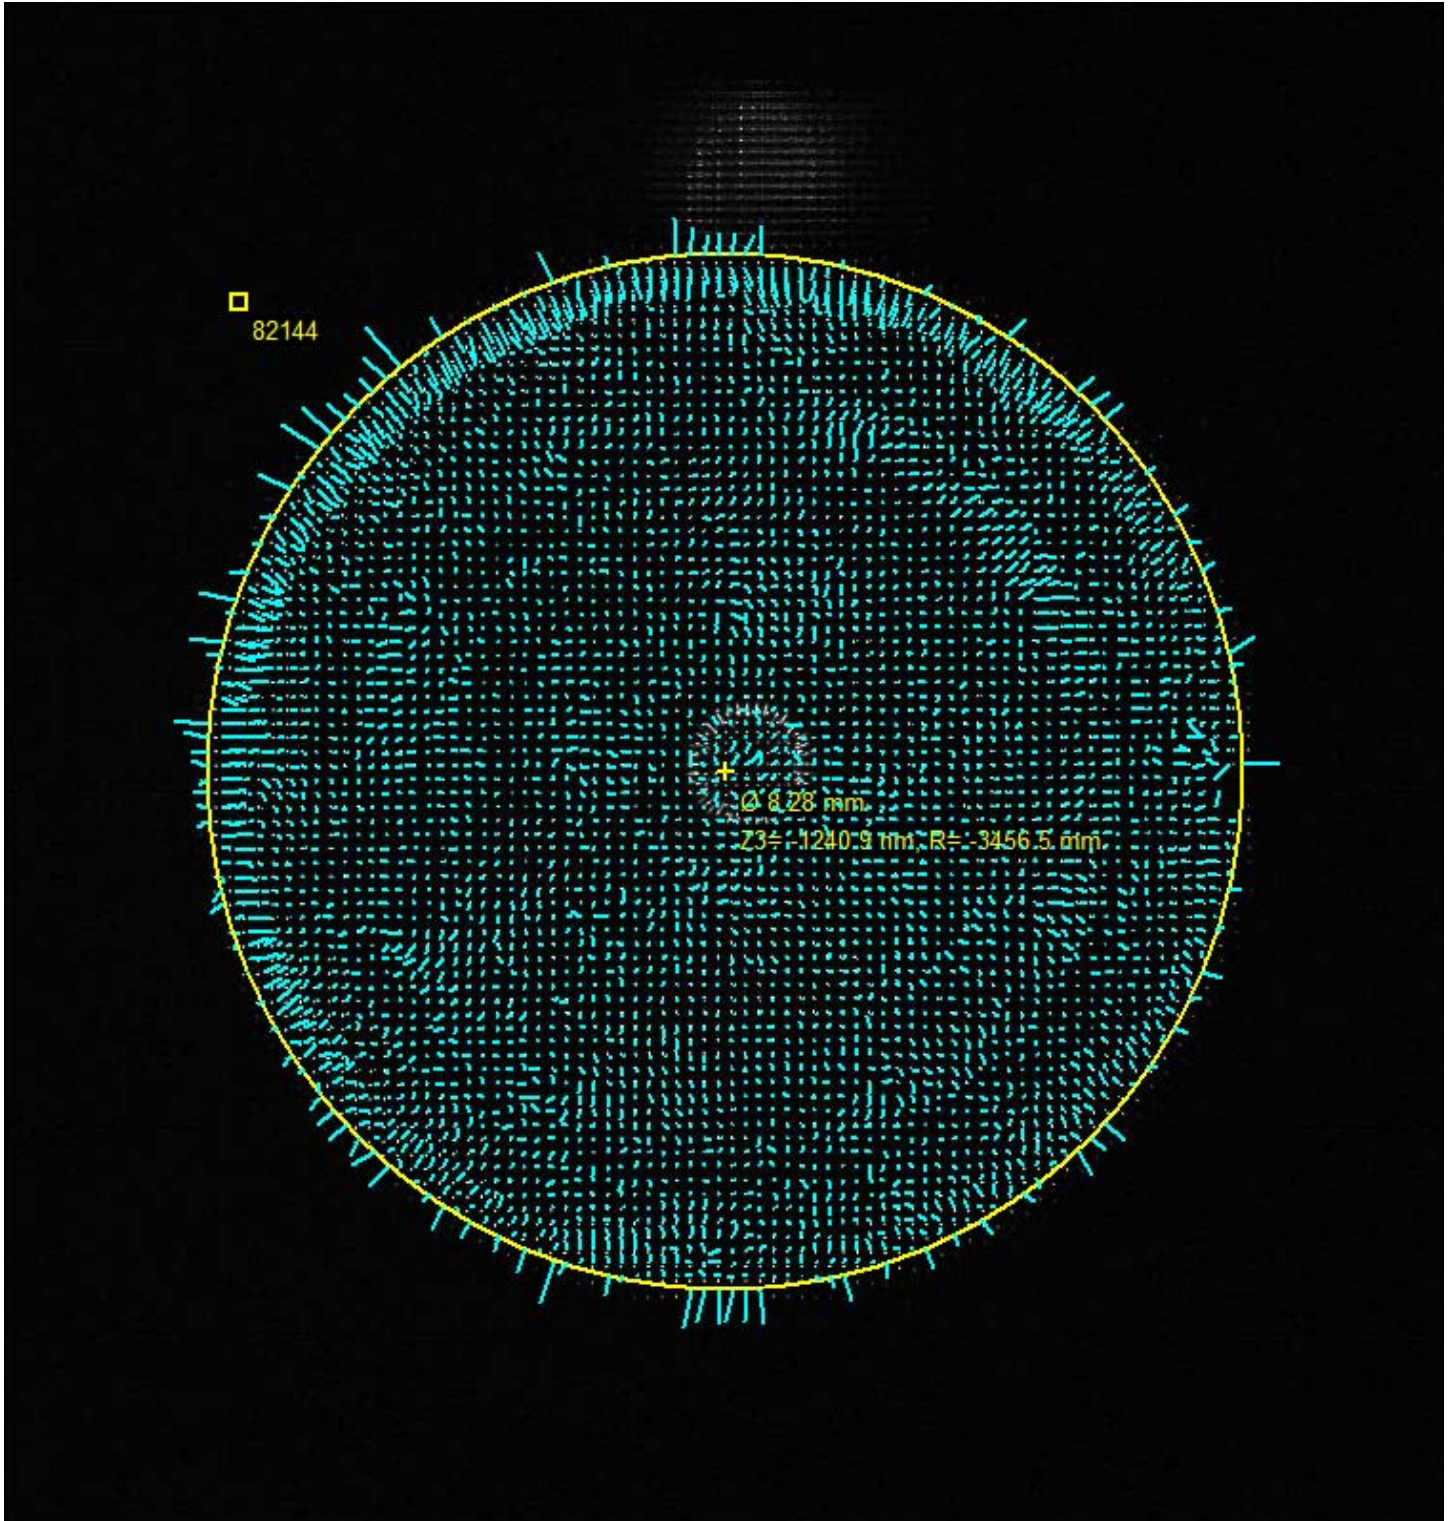
Figure 8.

At the Shack Hartmann level, this is very easy to carry out mirror diameter decrease. The analysis diameter has been reduced from Ø 1110 pixel down to Ø 1090 pixels

This can be achieved on the physical mirror by a 5.5 mm thickness outer ring. Analysis shows that spot elongation error is reduced by far on the mirror edge.

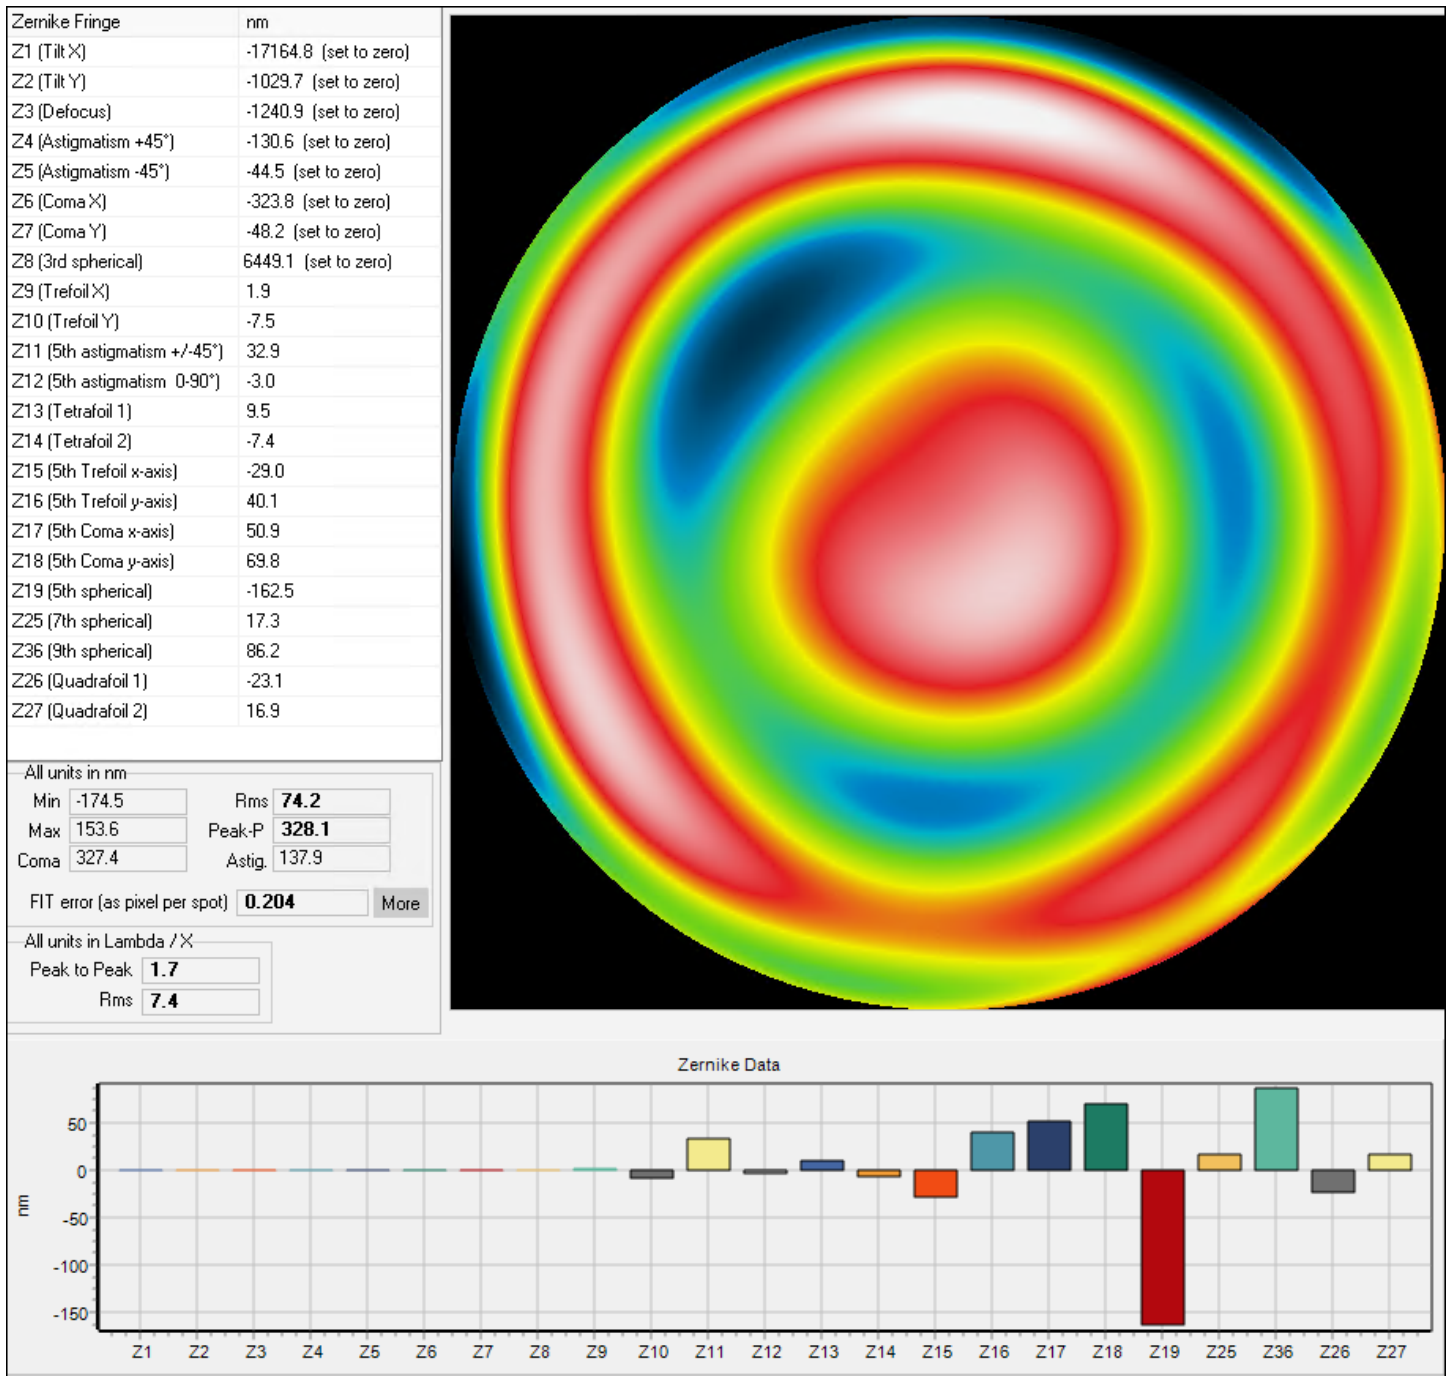
Figure 11.

Assuming an error of astigmatism due to the support (it turned out that astigmatism does not follow rotation when the mirror is rotated by 90°), the overall error is 74 nm rms ($\lambda/7.4$), that starts to be a good mirror.
